Upgrading mainland Europe's oldest iron suspension footbridge

Wissekerke castle park in Belgium contains mainland Europe's oldest remaining iron suspension bridge (1824). In 1989, after years of neglect, the Kruikeke town council bought the castle, park and finally, in 2006, the bridge. The Architectural Engineering Lab of the Vrije Universiteit Brussel (æ-lab) was consulted to put the refurbishment on the right lines and to check whether this bridge can stand the shift in function from private to public. This paper places the pedestrian bridge within the framework of 19th century bridge construction, determines its historical value, characterizes the used materials by metallographic methods combined with tensile and hardness tests, re-analyses the structure, proposes strengthening strategies and concludes with a renovation proposal that preserves all of the authentic elements, causes the least visual impact, is durable and guarantees continued public use.

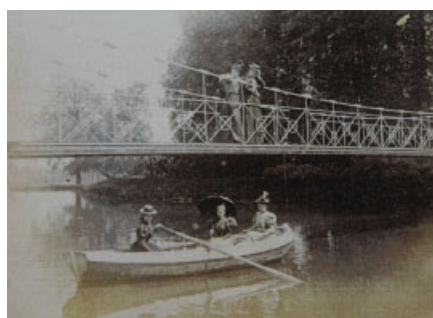
Fig. 3. Archive photo of the private suspension bridge at castle Wissekerke in 1905

J.-B. Vifquain based the design details of the Wissekerke bridge on the English construction details (Fig. 1 and 2). Similar to the Union Bridge, Vifquain used eye-rods for the main chain of his bridge. Since extensive research has not revealed any remaining construction documents, archive pictures (Fig. 3 and 4) and a thorough analysis of the existing structure form the only possible basis for evaluating the authenticity of the various bridge elements.

two-tone scheme is confirmed by the grey tones of the archive photos (Fig. 3 and 4). The fifth layer is cracked and dirty, which indicates a long period of neglect. The investigation shows that after 1915 the entire bridge was painted bright green. The cracks in this layer reveal a period of neglect again. In the mid-20th century the ironwork was sanded, protected with red lead and the entire structure painted white. The following layer is two-tone again. The most recent white scheme dates from 1990 [6]. Due to the current refurbishment works in progress, the application of a new protective layer has been postponed and the iron elements continue to degrade very quickly (Fig. 6 and 7).

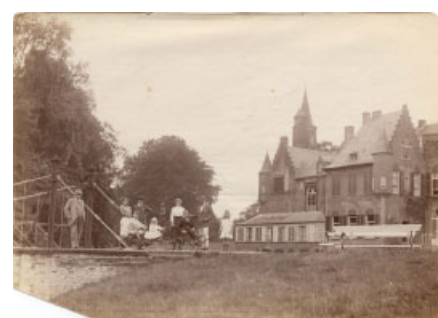
Fig. 4. Archive photo of the Vilain XIII family on the castle grounds in 1914 (courtesy of De Wilde, M.)

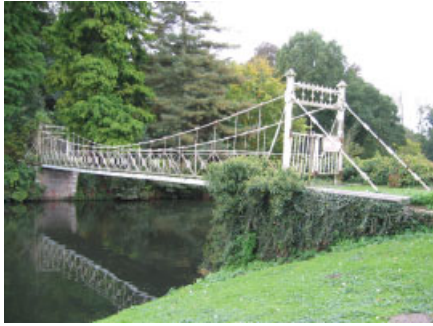
Fig. 5. Current state of the suspension bridge (2003)

Fig. 5 and 6 show the current state of the bridge. The bridge spans 23.1 m between the masts and has a deck width of 1.9 m. The suspension system is entirely symmetrical about the longitudinal bridge axis. At mid-span the suspension chain is 1.1 m above the deck and follows a catenary line up to 2.2 m above the deck at the ends of the bridge (i.e. the cast iron masts which are 2.9 m high). Each wrought iron suspension chain consists of individual eye-rods (1 m long, rectangular cross-section measuring 31 × 14 mm). These eye-rods and the vertical wrought iron hangers (rectangular cross-section 13 × 13 mm) which carry the deck are pinned together by means of connection plates (Fig. 7). Each suspension chain runs through the mast (Fig. 8) and is anchored to the abutment. The longitudinal stabil-

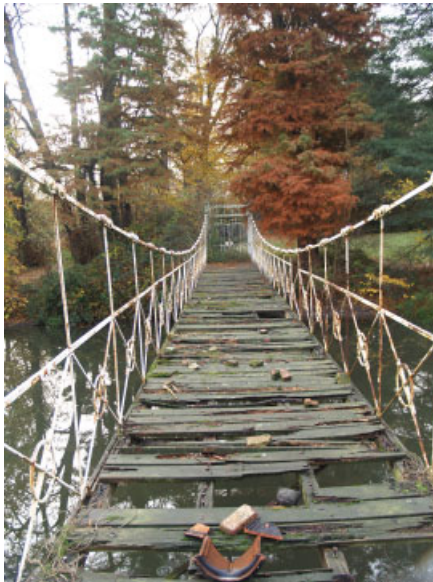
Fig. 6. View of the suspension bridge deck (2006)

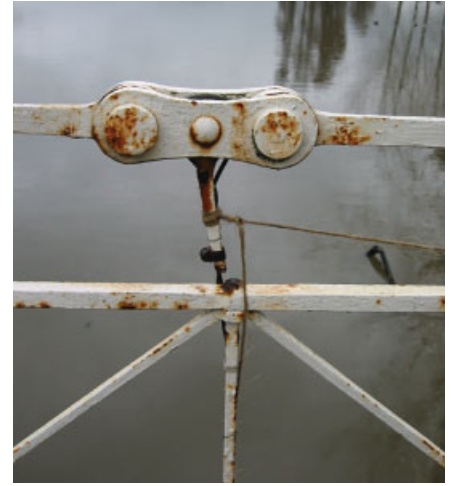
Fig. 7. Due to torsion of the bridge deck and corrosion, the vertical hanger has broken. The central bolt is not original (2003)

Currently, the bridge is in a very bad condition due to its exposure to the elements and lack of maintenance. The abutments have subsided, which has led to distortion of the deck and the metal railings (Fig. 7). All ironwork is corroded, several nuts and bolts are missing, four hangers are broken and one cast iron column shows a crack due to corrosion of the wrought iron suspension chain that passes through it (Fig. 8).

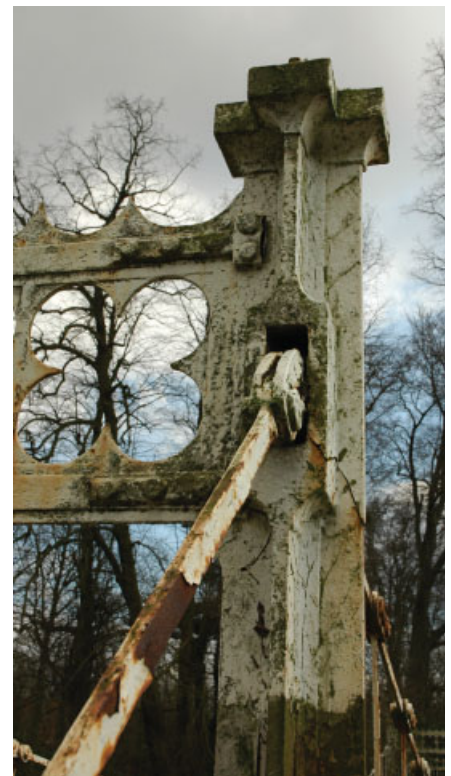
Fig. 8. Cast iron column with corrosion crack (2007)

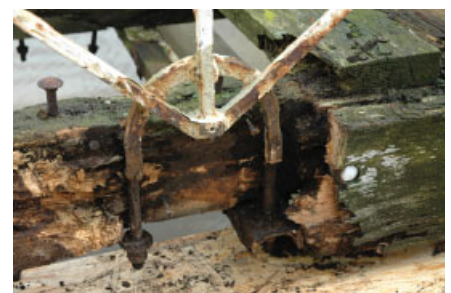
Fig. 9. Construction detail of the connection of the hanger to the channel section, which became visible after removing the side board (2007)

The current bridge deck consists of wooden boards fixed on four parallel beams along the longitudinal axis of the bridge. These beams are supported every metre by steel channel sections attached to the vertical hangers at their ends (Fig. 2). To analyse the connection between the vertical hanger and the channel section further, the wooden side board had to be partially removed. Fig. 9 illustrates how a hoop has been welded onto the vertical hanger and the diagonal bars of the railing. Bars with screw threads are welded to the hoop to attach the channel section with a bolt.

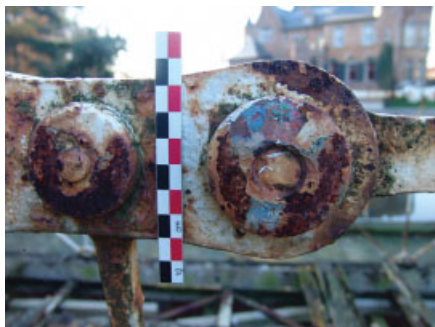
Fig. 11. Analysing the layers of paint on an eye-rod connector: red lead, dark blue, green, white

The investigation of the paint layers, which was carried out to reveal the original colour scheme of the ironwork, confirms the poor maintenance, even in early times. Fig. 10 shows the successive layers of paint on a column element (left) and a suspension eye-rod (right). On top of the undercoat of red lead there is a two-tone colour scheme. All the tension elements of the suspension cables, hangers and railings were dark blue, the compression elements, on the other hand, were dark green; oil-based paints were used for both. In the early 19th century, the bridge was repainted in these colours on a regular basis. This

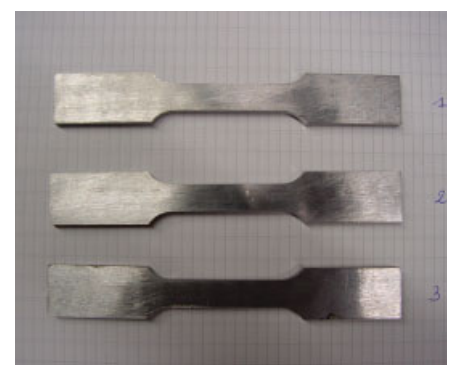
Fig. 12. Three test specimens cut from a sample of wrought iron railing

The railing sample was sawn into three specimens (Fig. 12) and tested, leading to a mean ultimate tensile stress of 350 N/mm^2 (which correlates very well with the empirical value derived from the hardness measurements) and a mean yield stress of 257 N/mm^2 for a mean elongation of 17 % [8]. Since only three specimens were available, the lower 1 % percentile of the population (instead of the usual 5 %) was taken into account to convert statistically the test results into the characteristic strength (table 1).
